BEAR CREEK LAKE DAM

NDI NO. PA-00610

CARBON COUNTY, PENNSYLVANIA

**PHASE I INSPECTION REPORT
NATIONAL DAM INSPECTION PROGRAM**

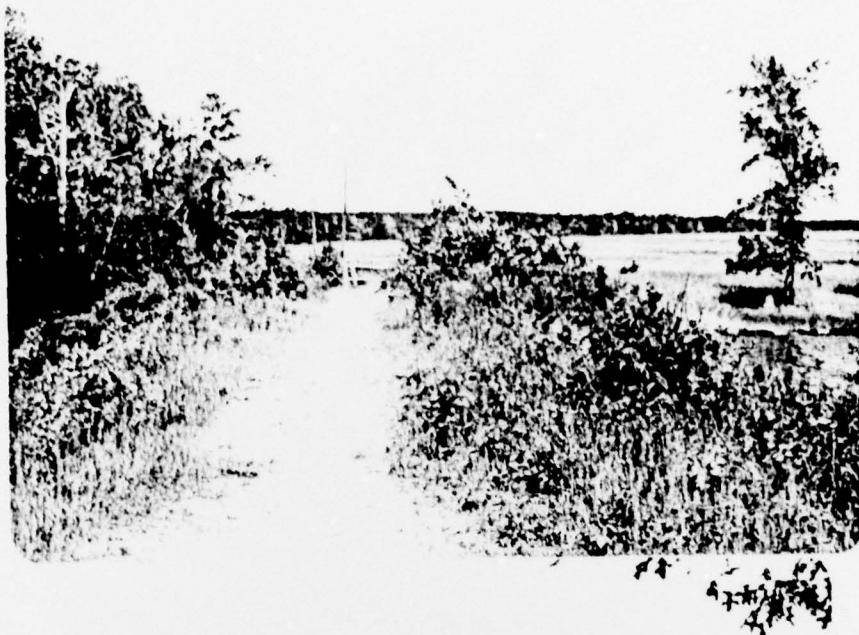
Dam Crest
Looking to
Right Abutment

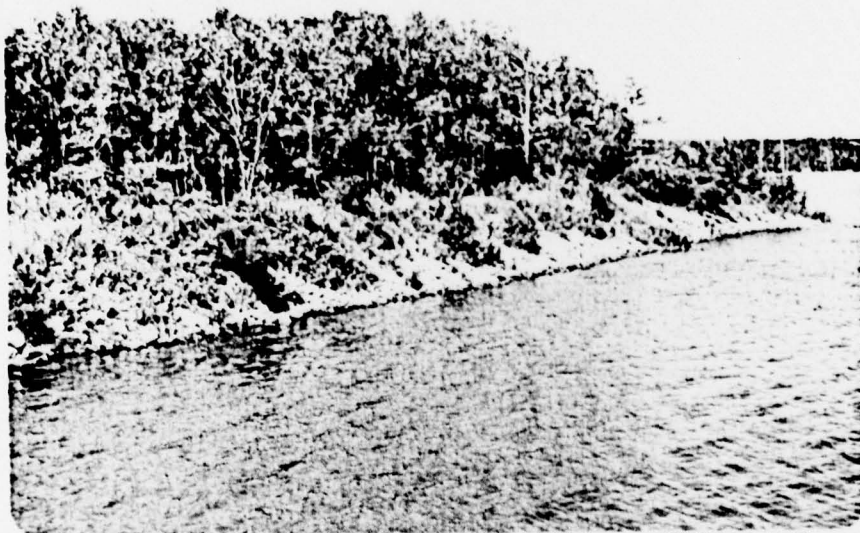
Upstream Slope

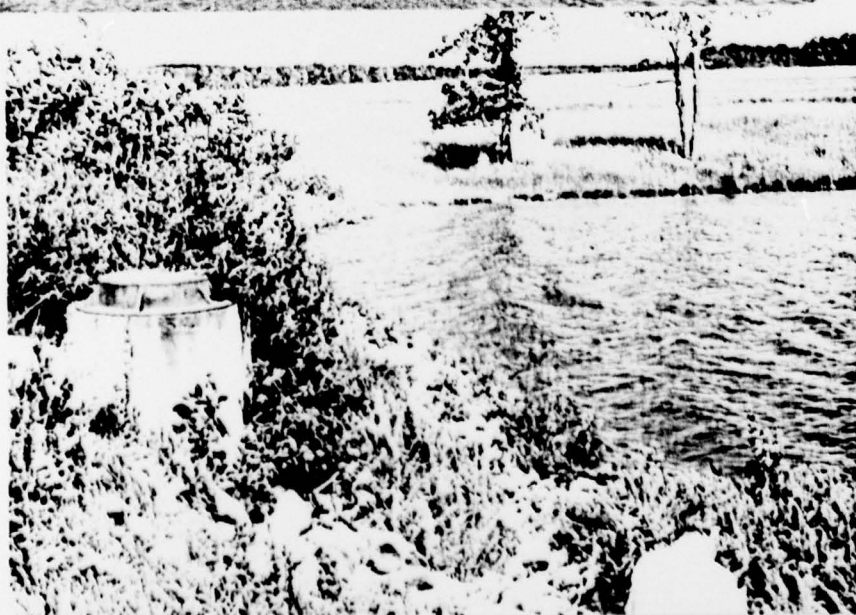
The control structure for the blowoff pipe is a precast concrete manhole. This structure is situated just upstream from the upstream edge of the embankment crest. The outside appearance of this unit is good. The owner indicated that there was no one available to open or operate the valve at this time; therefore, the inside of the structure and the valve could not be inspected. A sloped stem for the control of an upstream slide gate was observed projecting from the upstream slope at the water's edge. The owner indicated that this gate was installed several years after the completion of the dam when the lake was drawn down for repairs. This control was also not operated at the time of this inspection. The stem is in a very rusted condition.

Manhole with
Valve Control

The condition of the control valve and slide gate and the ability to operate these devices was not established during this inspection. A program should be developed for the operation of these controls at least once each year.

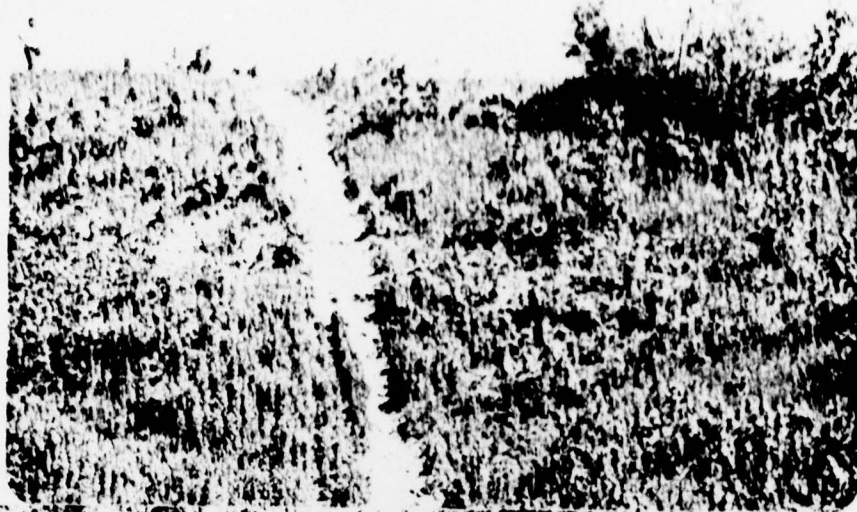
Downstream Slope
with
"Bike" Path

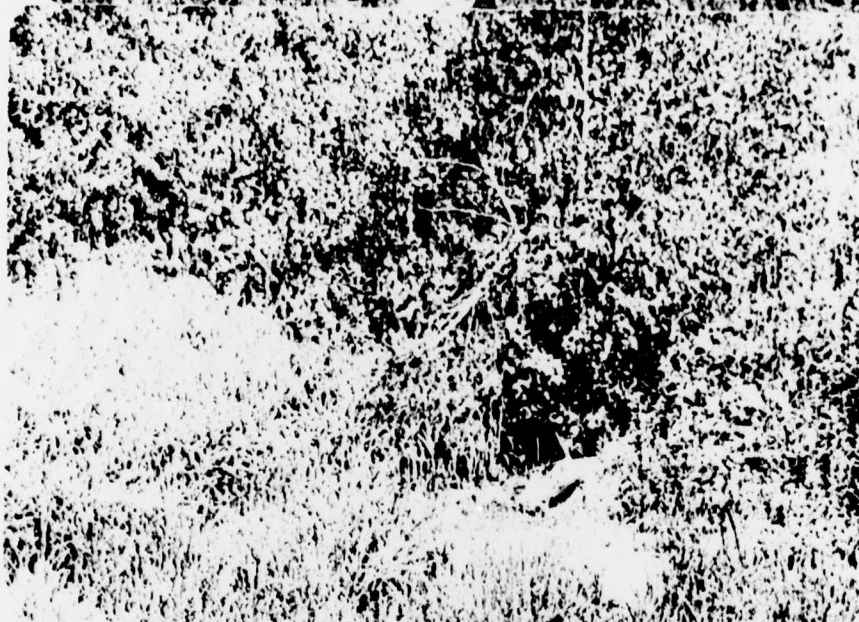
Seepage was noted at the downstream toe and beyond at several locations. At one location, near the outlet structure, the water was stagnant with no apparent flow. The ground surface, beneath the water, was rust colored. A second location, near the right abutment, was actually flowing. The discharge point was right at the toe and the source appeared to be beneath the embankment. Here, again, the bottom was rust colored, but the water was clear.

Recalling that the cutoff excavation during construction encountered considerable amounts of wet mucky material in the foundation area and that the cutoff feature had to be changed to a concrete cutoff wall in order to control the water from the springs at this location, and that the prime source of water, supplying the reservoir is numerous springs, it is most probable that this water, seeping from below the toe

The seepage observed during the visual inspection appears to be coming from springs under the embankment rather than through the embankment. This condition should not cause any stability problems for the structure. It should, however, be observed on a regular basis.

Seepage of Springs
at
Downstream Toe

3. That the removal of growth on the downstream slope be extended to ten feet downstream from the toe of the slope to allow close observation of the seepage in this area.
4. That regular observations of the seepage condition along the toe of the downstream embankment slope be made and recorded. If changes in volume or clarity are noted, immediate action should be taken to assess and remedy the condition.
5. That the control structure be inspected and examined for pipe alignment and settlement and that the control valve in the structure and the sloping gate on the upstream intake structure be operated to assure their use in the event of an emergency.
6. That the hole adjacent to the right spillway outlet channel wall be cleaned and backfilled.

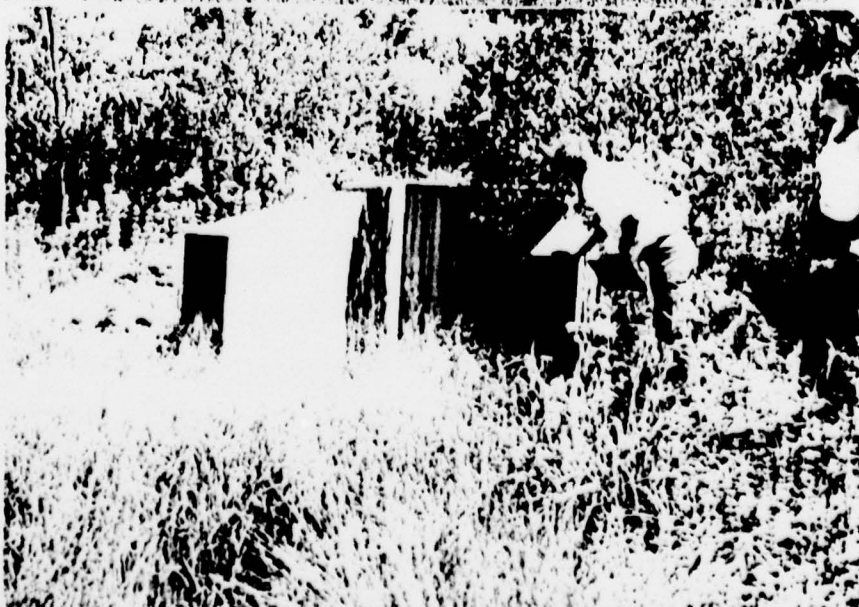
The blowoff pipe is noted on the design drawings as a 30-inch diameter concrete encased steel pipe with cutoff collars on 20-foot centers along the pipe. This pipe was measured as 24 inches at the outlet structure. The outlet structure is a rectangular concrete stilling basin 20 feet in length and six feet wide. This structure discharges to a narrow shallow channel which is partially filled with weed growth, indicating no recent flow through the channel. There was no flow from the outlet at the time of this inspection.

Conduit Outlet

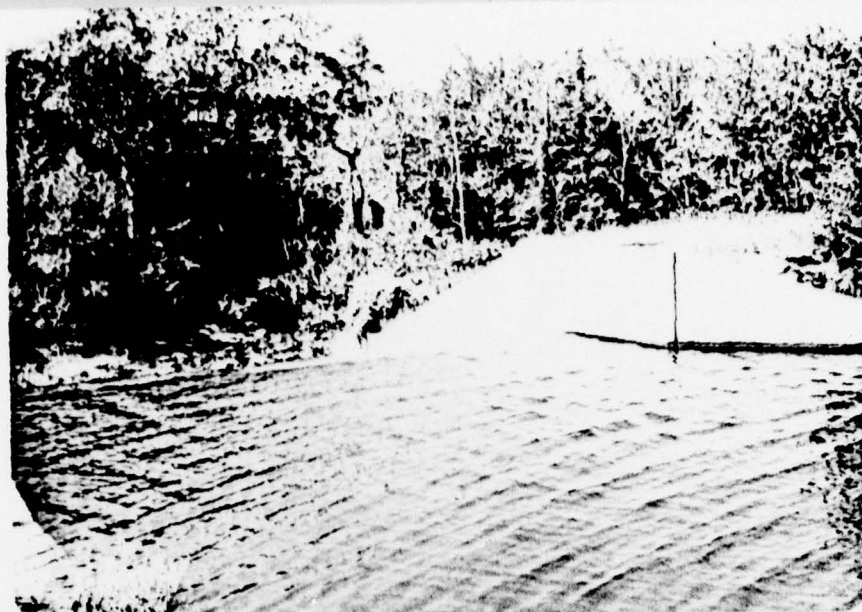
Forebay of
Spillway

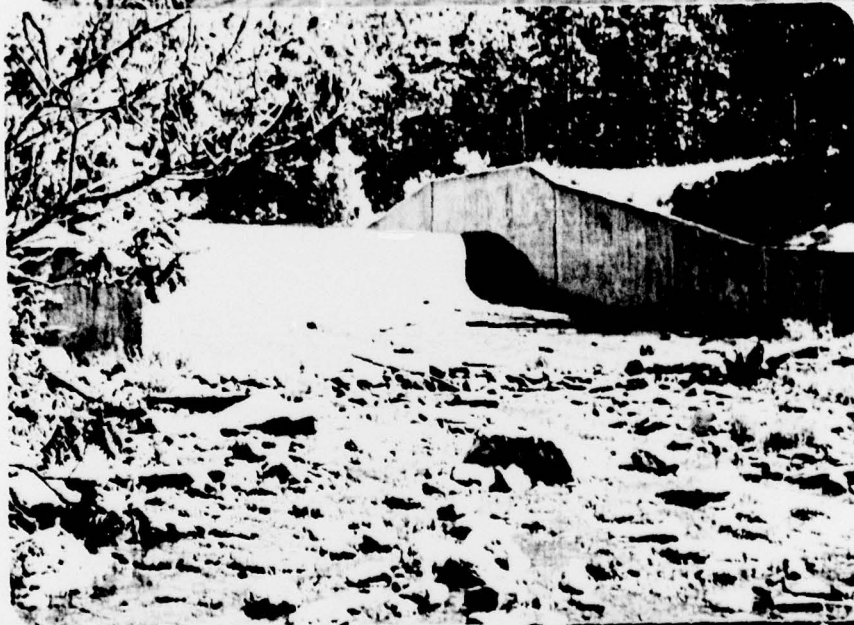
The uncontrolled ogee spillway section was observed to be in very good condition. The approach to the spillway is directly from the reservoir and is unobstructed. The depth of the water, on the upstream side of the weir, was 2.3 feet. Water was just flowing over the crest at the time of this inspection. The concrete lined outlet channel, from the ogee spillway to its terminus is also in good condition. The slopes and walls did not show any signs of distress. The natural channel, downstream from the slab, is unobstructed with a rocky bottom and short slopes. Trees and brush cover the overbanks.

Spillway Looking
Upstream

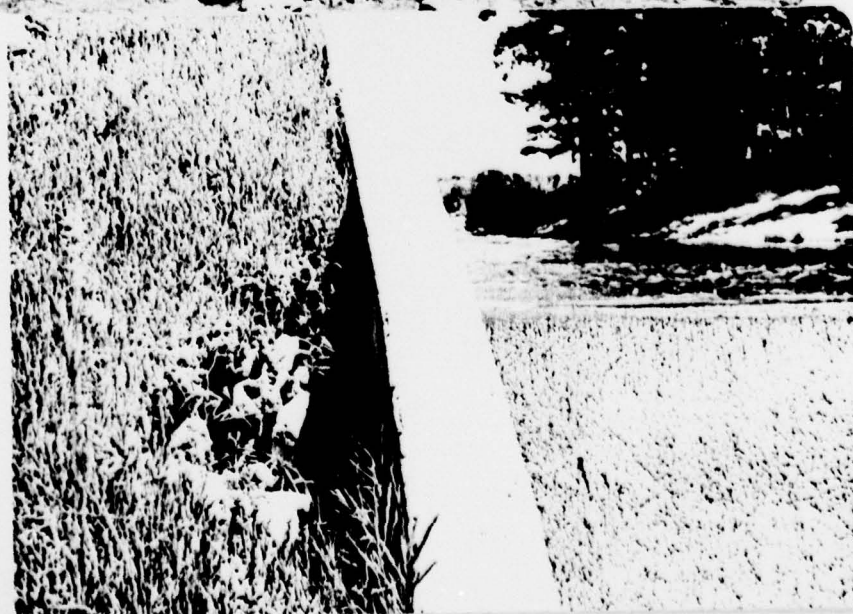
One hole was observed in the embankment adjacent to the right spillway channel wall. This hole is about three feet by six feet in area and about three feet deep. Large stones were noted in this hole. This condition should be repaired to prevent further erosion.

The spillway, spillway outlet channel and walls all appear to be in stable condition. There is no indication of major cracking of the concrete and the walls show no evidence of tilting. At one location on the downstream slope, adjacent to the right spillway outlet channel wall, there is a hole in the embankment. This hole is about three feet by six feet in area and approximately three feet in depth. This hole has not caused any distress to the wall, but should be repaired to prevent any future problems.

Settlement
Adjacent to
Right Spillway
Wall

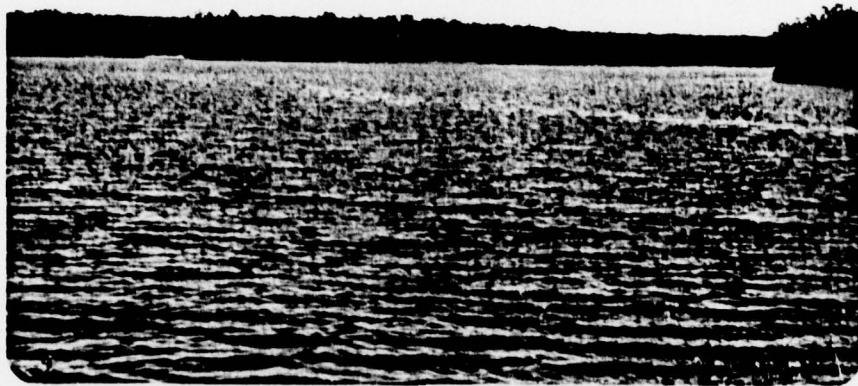
Reservoir

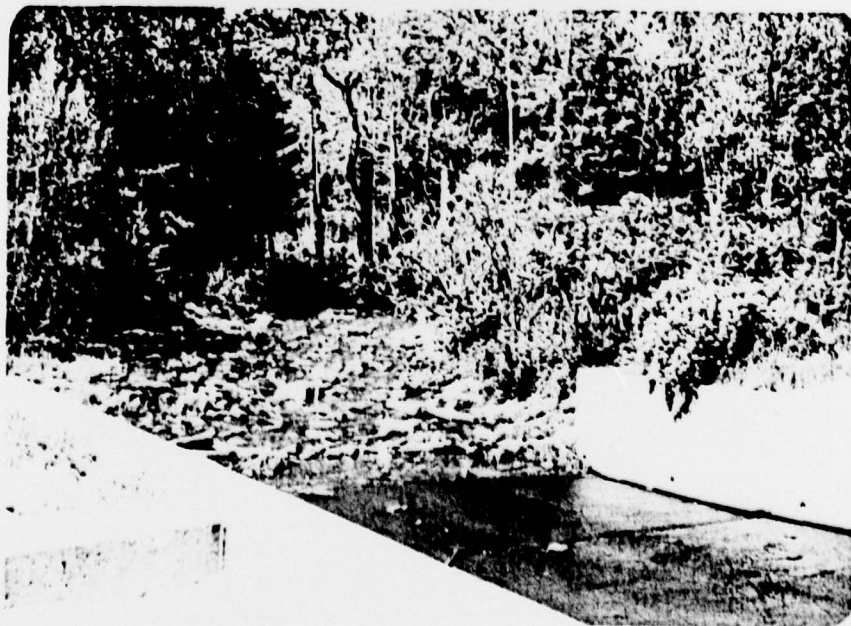
Downstream Channel
